PENNSYLVANIA  
**FISHPOND DAM**

NDS ID NO. PA-899  
DER ID NO. 19-81

PHASE I INSPECTION REPORT  
NATIONAL DAM INSPECTION PROGRAM

NAME OF DAM	Fishpond Dam
STATE LOCATED	Pennsylvania
COUNTY LOCATED	Columbia
STREAM	Unnamed tributary to Roaring Creek
DATE OF INSPECTION	November 20, 1979 & April 8, 1980

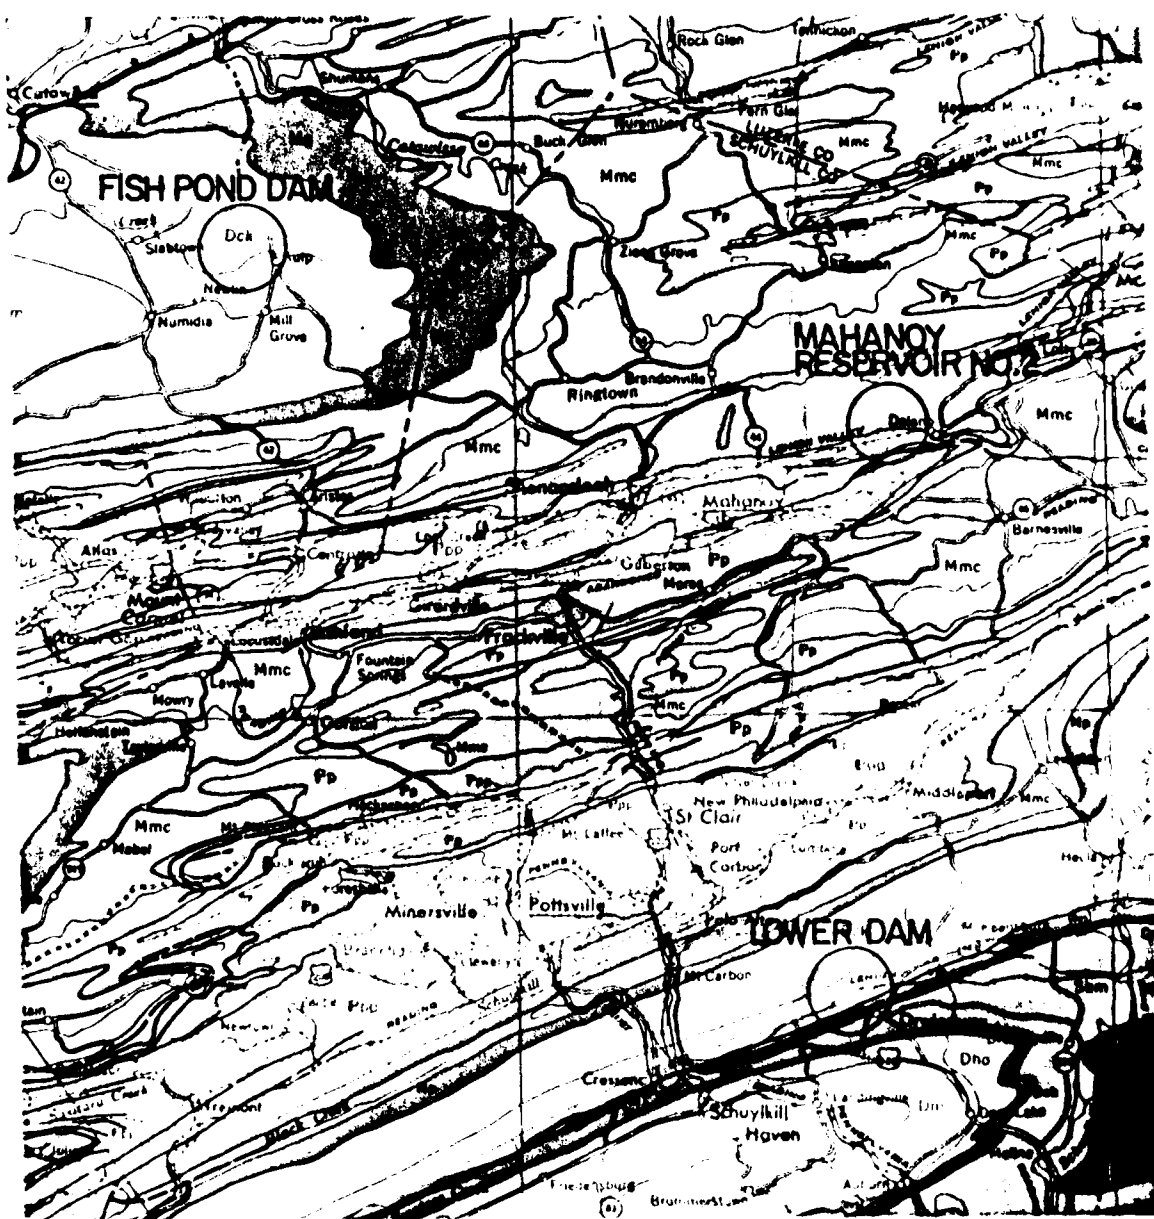
GEOLOGICAL MAP OF THE AREA AROUND FISH POND DAM,  
LOWER DAM AND MAHANOEY DAM NO. 2.

Fishpond Dam lies within the Appalachian Mountain Section of the Valley and Ridge Physiographic Province. This area is characterized by overturned and assymetric folds, local shearing and large, low-angle thrust faults. There is some minor faulting indicated a few miles to the west and also to the northeast of the dam.

The bedrock underlying the dam consists of the Devonian aged Catskill formation. This is a complex unit consisting of sandstones, siltstones, shales and conglomerates. The usually well developed beds range in thickness from less than one foot to over fifteen feet. The well developed and closely spaced joints in the siltstones and shales are steeply dipping and form blocky or platy patterns. The formation is moderately resistant to weathering, except for the shales, which disintegrate rapidly. The foundation stability for heavy structures is good if excavated to sound material and the shales and siltstones are kept water free.
